**A proactive and preventative product that provides centralization and protection, for the polished rod, the wellhead and surface components of the Artificial Lift oil production process.**

# **SENTINEL** Polished Rod Protection System

It is a revolutionary, patent pending, two part bushing designed for the protection of the polished rod, stuffing box, packing and wellhead components.

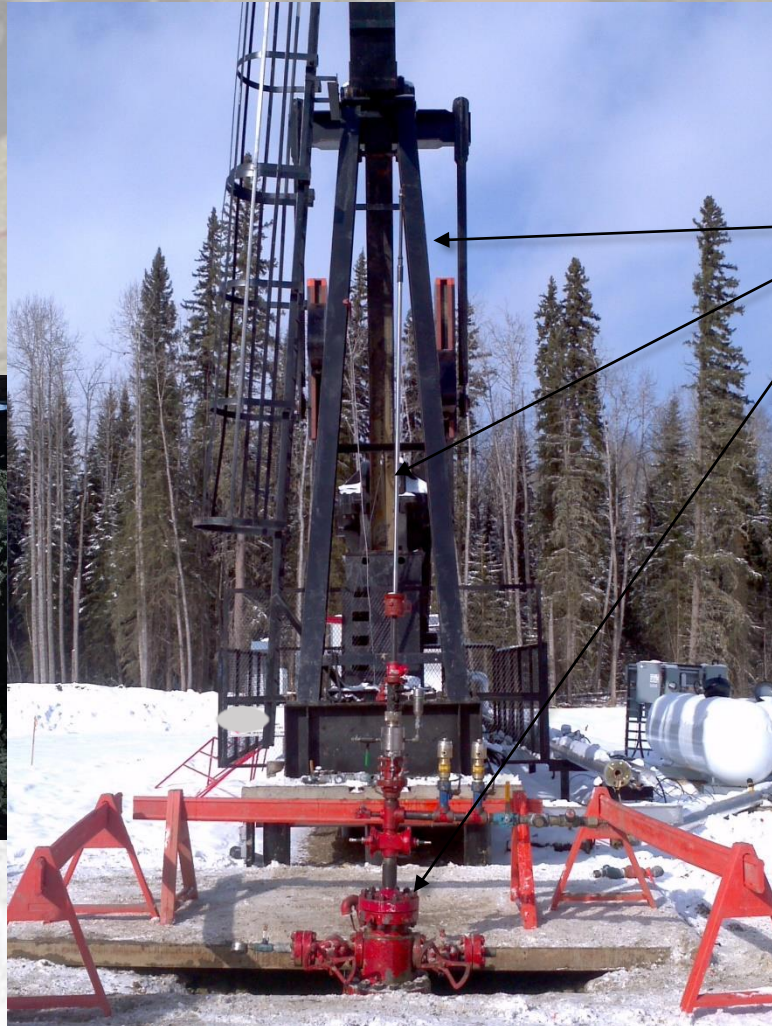
Notice how much deviation is apparent over a distance of 4m once the bowl welded straight with the casing.

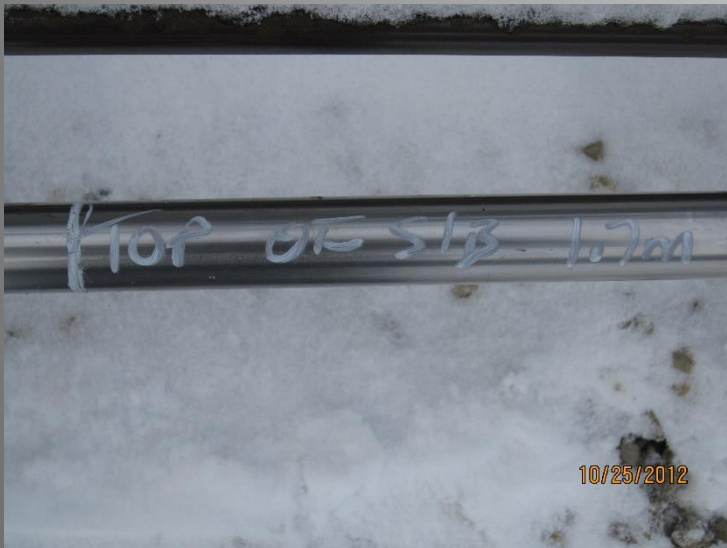
Measurement indicating tubing hanger position on polished rod and the top of the scoring.

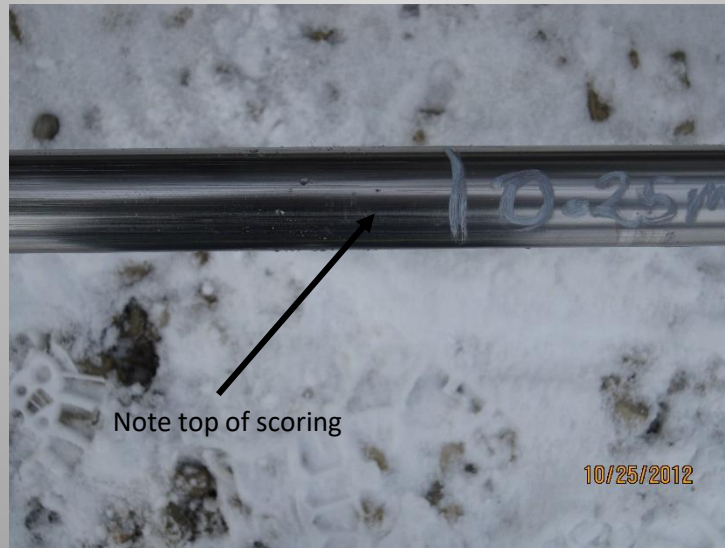
Measurement indicating total length of scoring on polished rod.

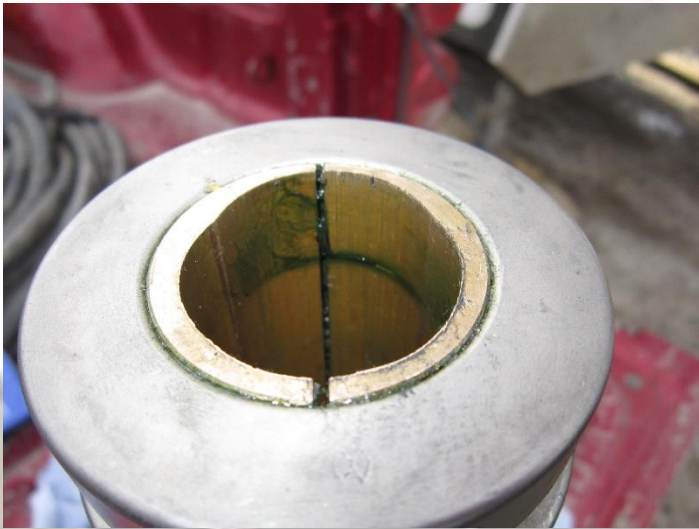
Top packing nut on Nelgar Stuffing box

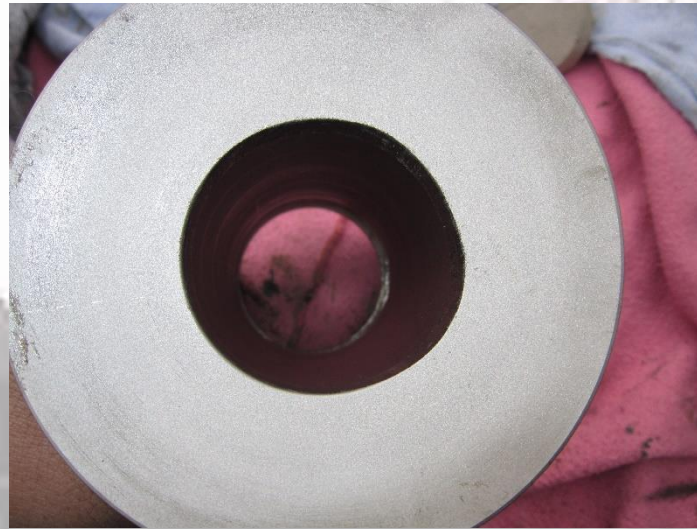
Knuckle flange on Nelgar Stuffing box

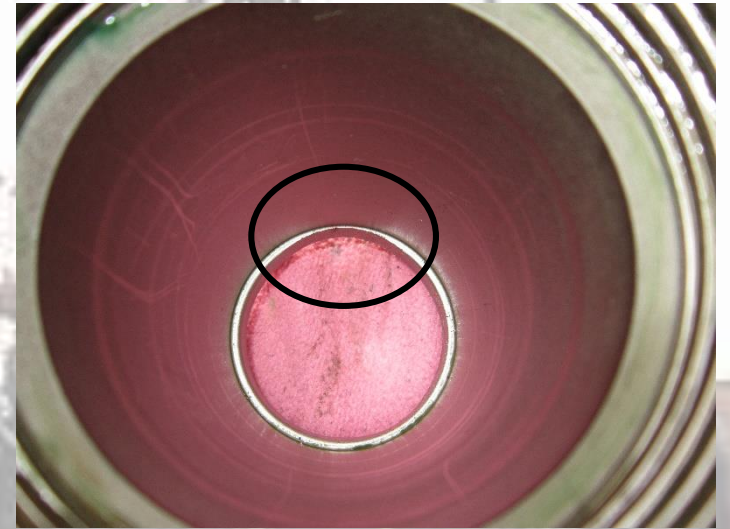
Packing chamber on Nelgar Stuffing box

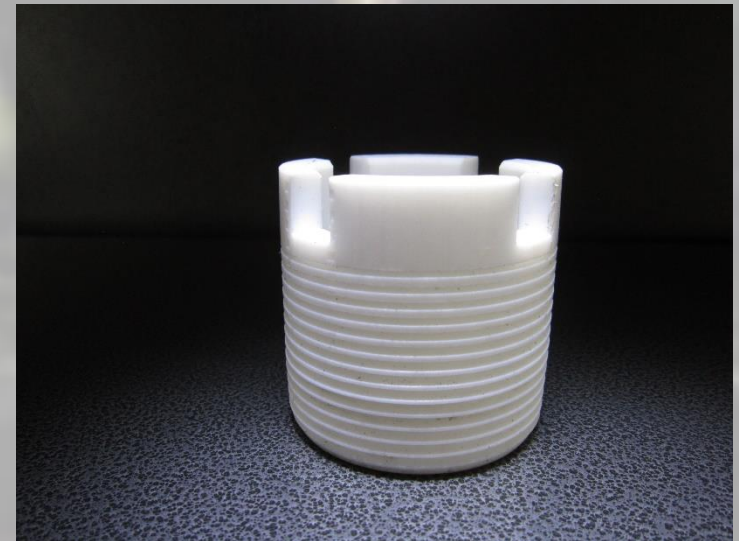
## Sleeve

The **SENTINEL** sleeve provides a landing and latching point for the second piece (Insert Bushing).

The sleeve is installed into the tubing hanger, below all other wellhead equipment and has a large enough ID that any wireline tools that may need to be run in the future, **can be run without it's removal.**

Machined with EUE threads to API specifications. The sleeve can be custom machined to meet the customers needs.

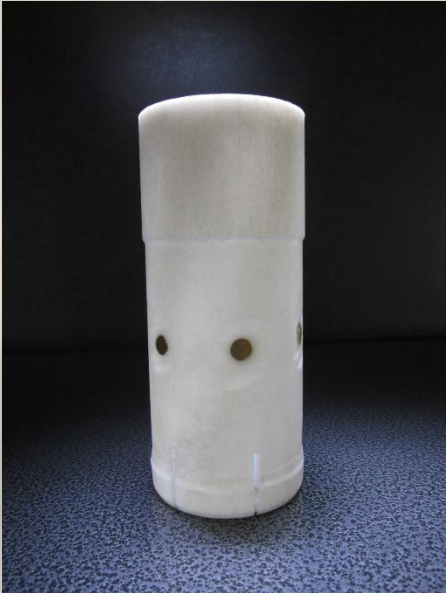
## Insert Bushing

- Machined from PTFE for its characteristics
- Designed with a no go Profile that will not pass through sleeve.
- Designed with a collet latching system for easy installation and retrieval
- Helical fluting to allow for fluid by-pass yet maintain polished rod support over the length of the bushing
- Brass wear indicators, to indicate when fluting has worn +/-50%
- Brass indicators leave a vertical brass discolouration on polished rod that does not get wiped off by stuffing box packing.
- Available in assorted sizes and matched to the sleeve.
- Fluid passages are maximized to prevent backpressure (<100kPa pressure drop @ 144m<sup>3</sup>/day)
- Installed below isolation equipment to prevent interference with their operation. (ie. radigan and stuffing box)

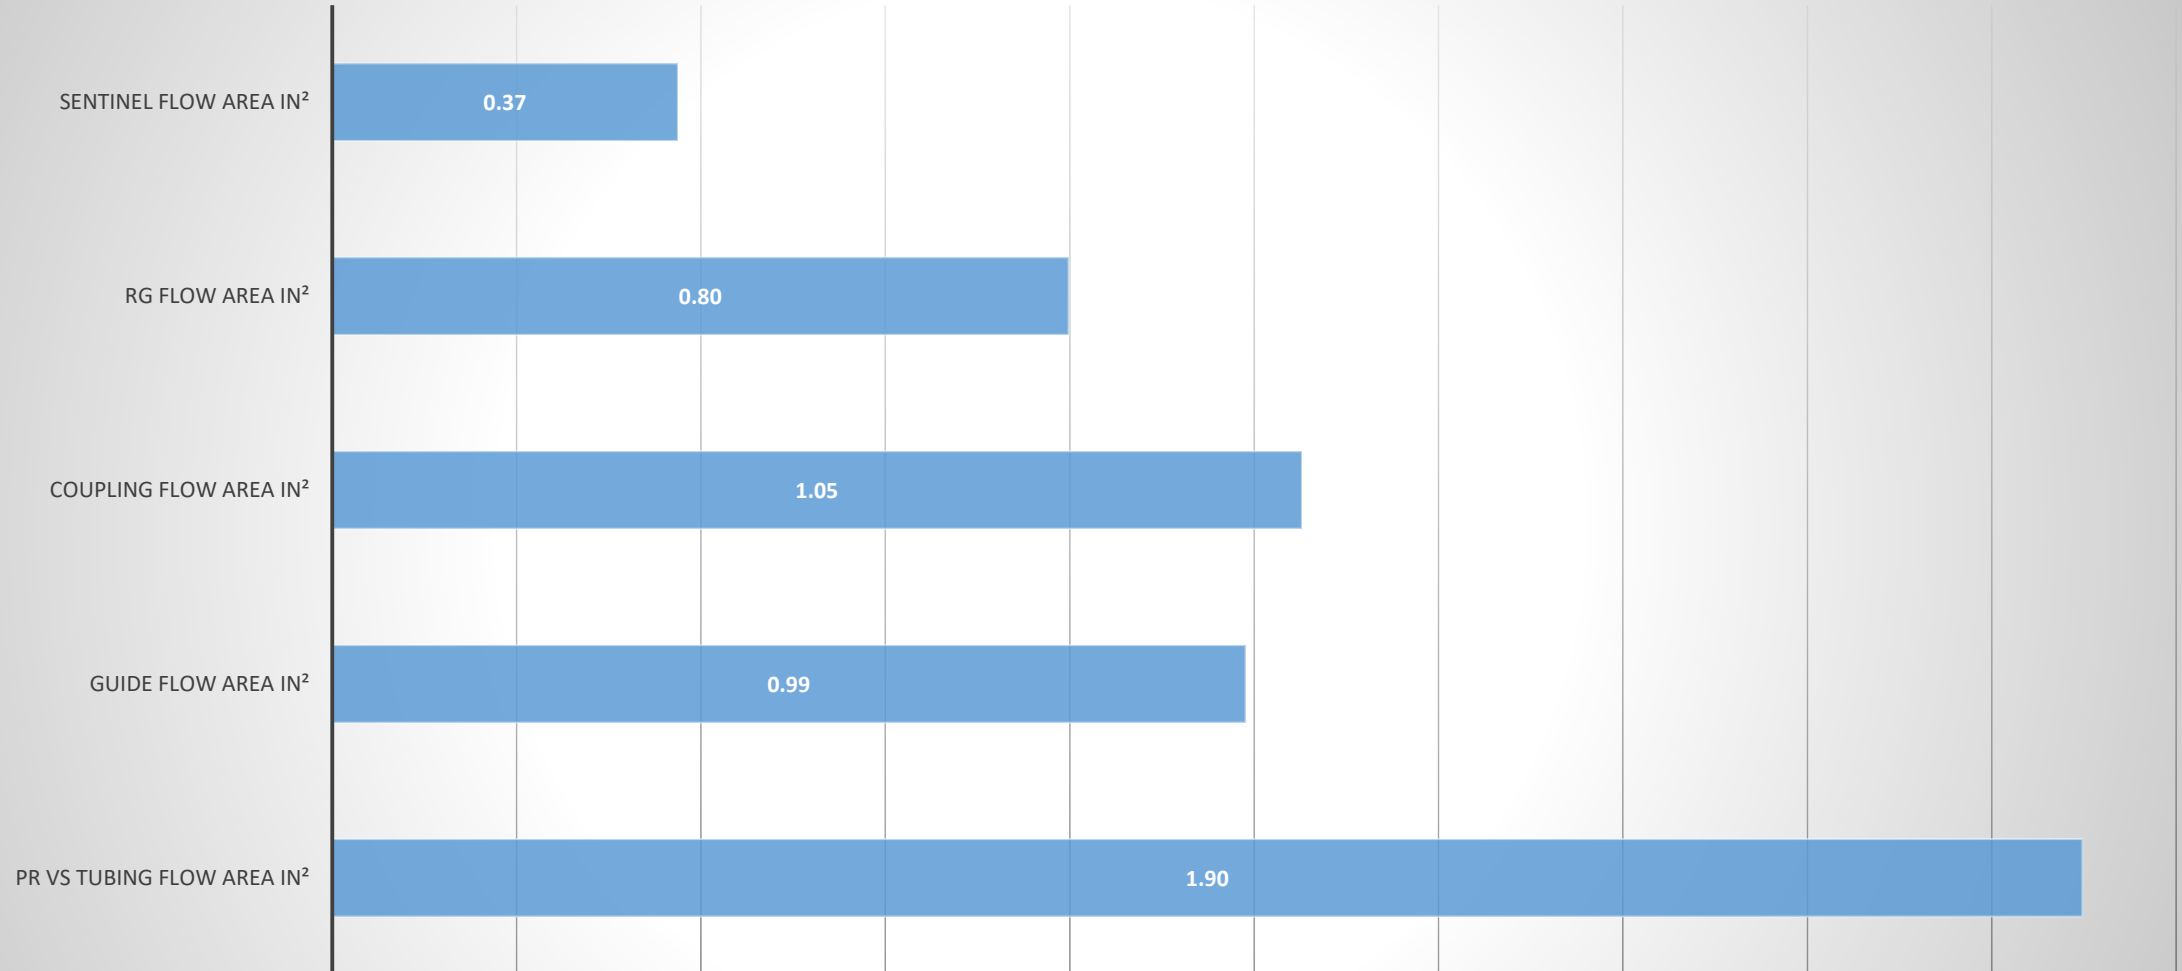
## Comparisons of Flow Areas in 60.3mm Tubing

■ 60.3mm / 31.75mm polished rod
